# INDUSTRIAL ARCHAEOLOGY IN THE BLACKLOG NARROWS

A Story of the Juniata Valley Iron Industry

Scott D. Heberling  
Heberling Associates, Inc.

2007

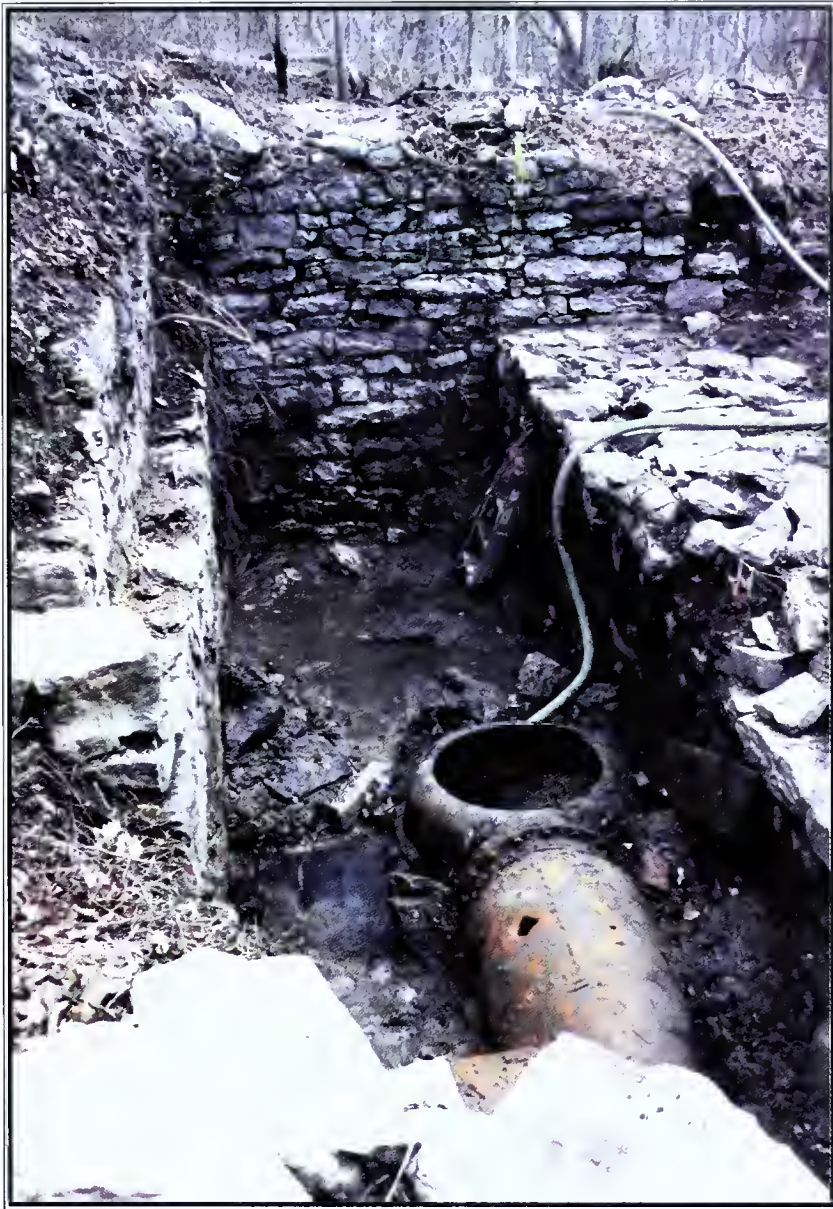
*Interior of Cromwell Mill after excavation, showing intact turbine housing and tailrace.*

At the Cromwell Mill, archaeological excavation revealed well-preserved remains of the turbines, headrace and tailrace, as well as the boiler shed and the massive interior walls that supported the mill machinery and millstones. The historical and archaeological evidence demonstrated that the operators of the mill—especially Percival P. Dewees—were quite willing to adopt new technology like turbines and supplemental steam power that would improve efficiency and make their enterprise more competitive and profitable, even though they continued to rely on water as the principal power source. Though many people think of rural water-powered mills as “quaint,” this study and others suggest that millers often were on the cutting edge of technological innovation. They used whatever technology worked best for their specific situation.

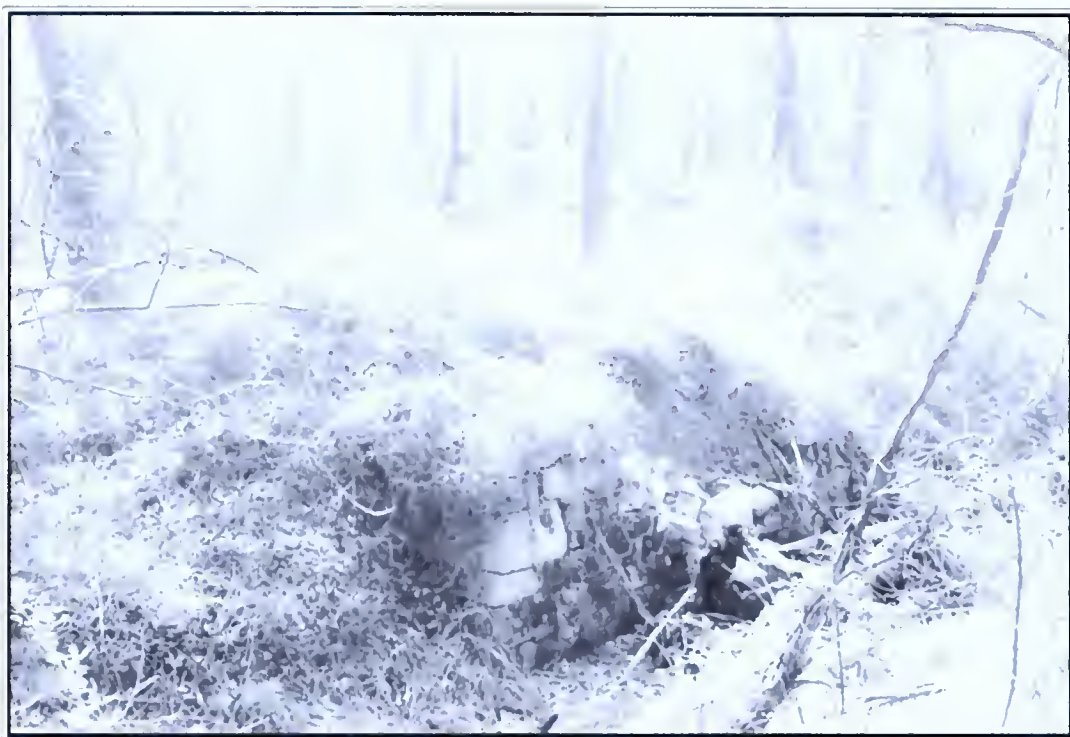
*Ruins of Winchester Furnace stack, before excavation.*

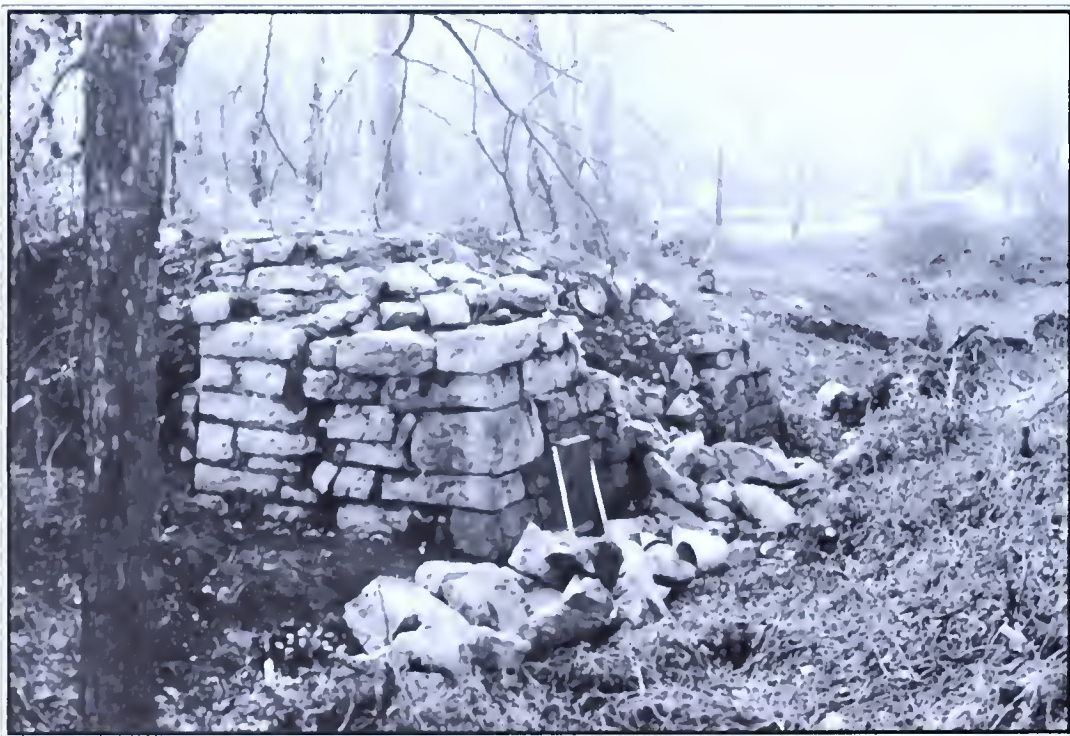
*Ruins of Winchester Furnace stack from same perspective, after excavation.*

Winchester Furnace was located at the lower end of the race, a few hundred feet west of the mill. Because it was the last of the three industries to be established, it was relegated to the poorest site, only a few feet above stream level. Though it had the requisite water power and adjacent hill, the low ground was usually wet and subject to frequent flooding. Historical sources emphasize that wet conditions were disastrous for smelting iron. Archaeology confirmed that the area had been filled extensively before the stack was constructed. The furnace site was very constrained, squeezed between the steep hillside and the road and creek, so the buildings attached to the stack were quite small.

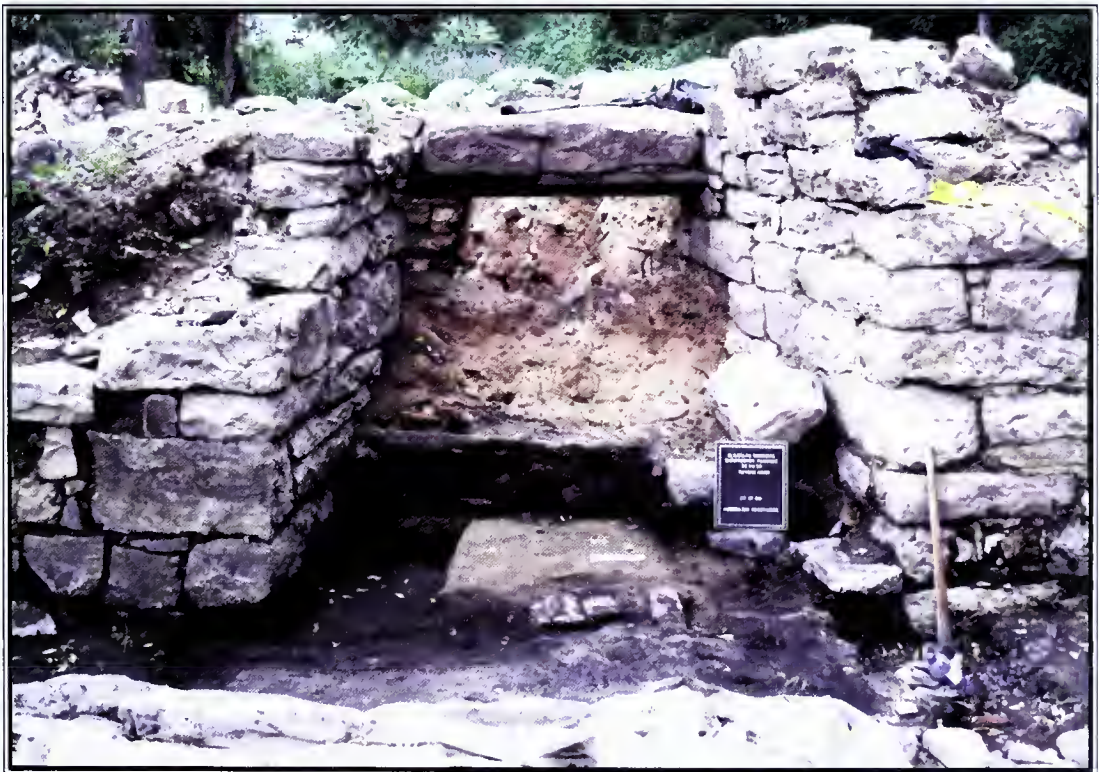
*Remains of tuyere arch at Winchester Furnace.*

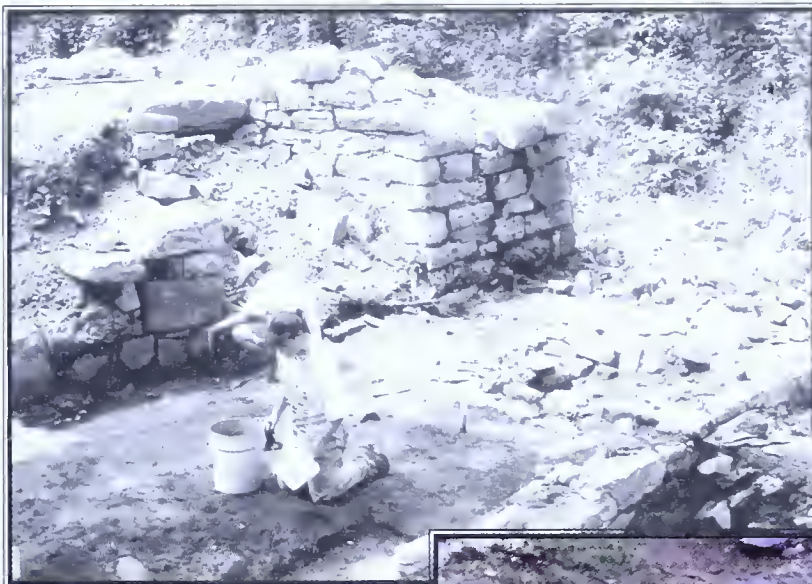
*Excavation of east room  
at Winchester Furnace.*

The well-preserved remains of the blast shed were found east of the stack. The most important archaeological feature in this room was a 9-foot by 16-foot dry-laid stone platform that supported the blast machinery. Although the machinery was gone, it probably consisted of a pair of blowing cylinders or tubs and a mixing box, powered by a shaft from a vertical undershot water wheel in the adjacent race. As in the other rooms, the work floor in the blast shed was almost completely intact.

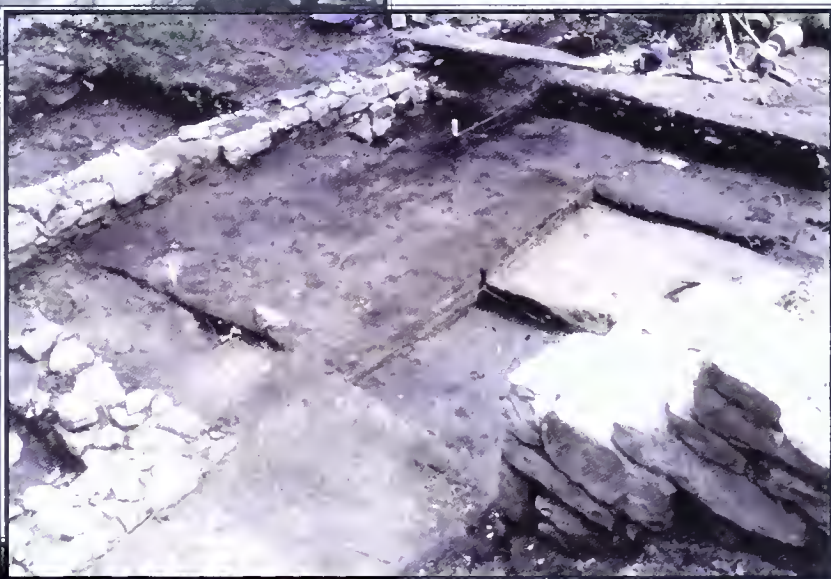
*East room at  
Winchester Furnace  
after excavation,  
showing surface of  
historic work floor. View  
is from top of stack.*

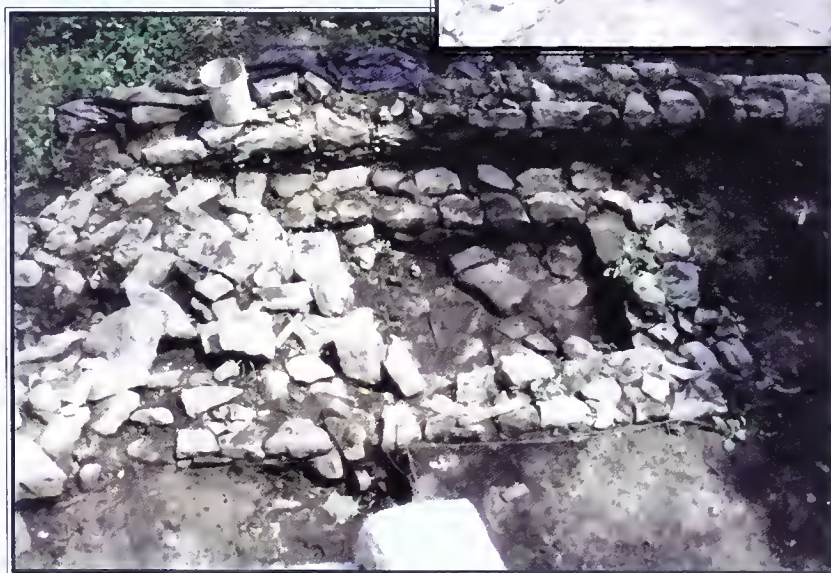
*Winchester Furnace:  
stone platform for  
blast machinery.*

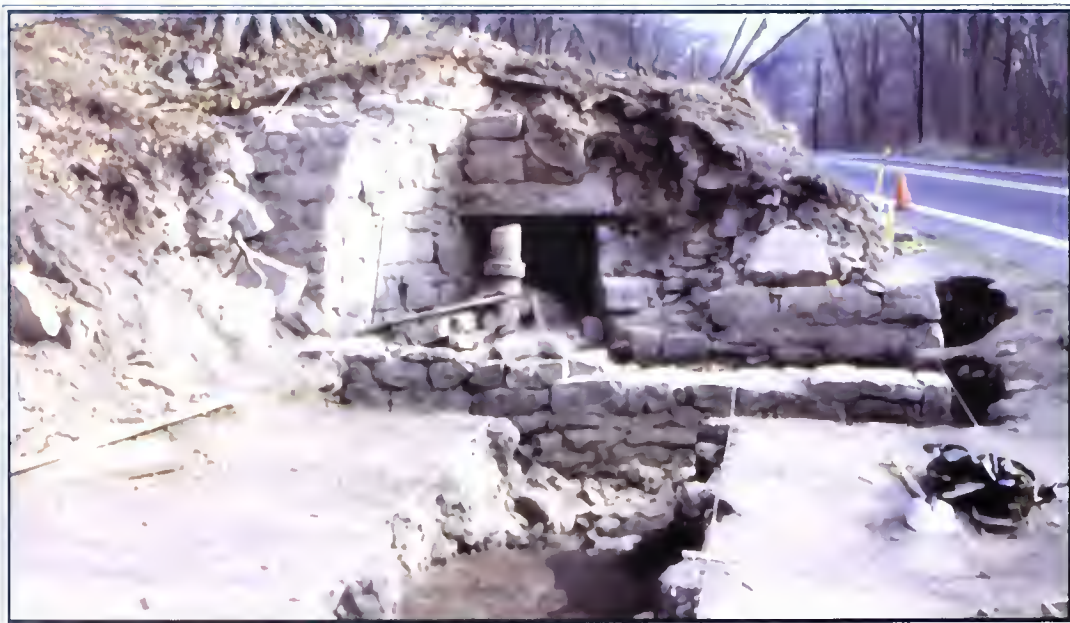
*Ruins of Rockhill Furnace stack after excavation.*

Rockhill's stack was slightly more intact than Winchester's, though little remained of the portion nearest the road. It was obvious that at some point the stack had been enlarged by application of an outer layer of stone on all four sides, resulting in a visible seam; this most likely occurred during the repairs that followed the collapse of the stack in January 1846.

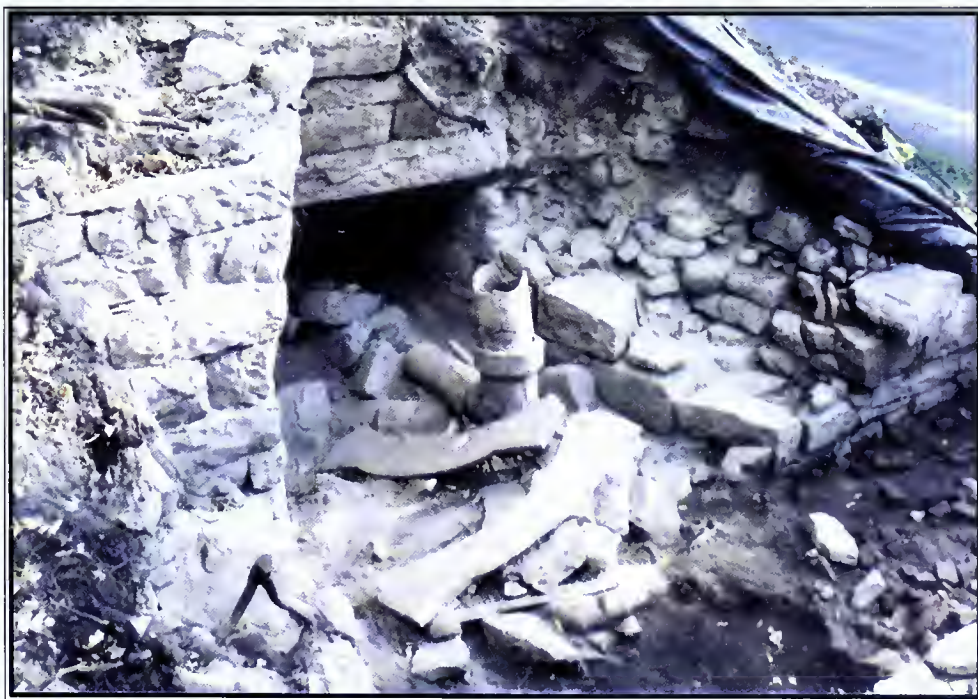
*Tuyere arch at Rockhill Furnace after excavation, showing intact "downcomer pipe".*

All three arches were intact. The front face contained the casting arch, with its cast iron lintel and fire brick lining still in excellent condition, despite being only a few feet from the highway. Part of the casting floor and sand beds had survived, as they had at Winchester. But unlike the other furnace, each tuyere arch contained a cast iron blast pipe that supplied air to the crucible, and in the west arch there was even a section of the "downcomer pipe", a crucial part of the hot blast system that recirculated superheated air from the top of the stack. Near the downcomer, three large cast iron plates lay amid the rubble on the work floor. These were the plates that framed the opening in the top of the stack, and they lay where they were thrown when the stack was dismantled, along with brick rubble from the chimney. Archaeology also revealed the remains of a system of underground pipes that brought water to cool the tuyere nozzles, which were exposed to intense heat during the blast. Since water-cooling was not adopted in Britain until 1834, and took a little longer to reach America, this could not have been part of the original construction.

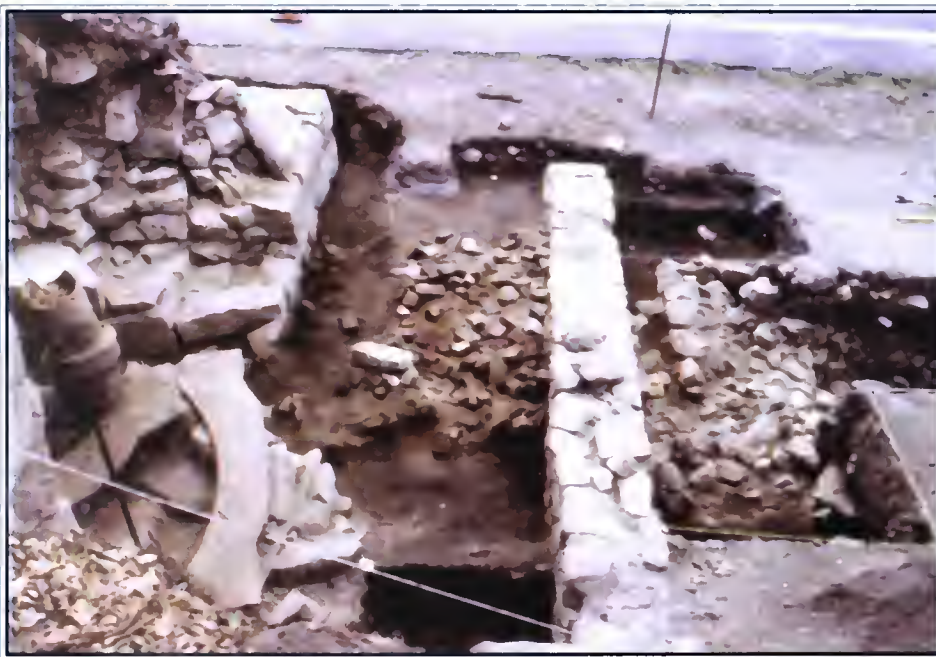
*West room at Rockhill Furnace after excavation. Brick rubble (center) and curved iron plates (left) were thrown from top of stack when furnace was dismantled about 1876. Stone rubble (right) was deposited when site was filled and leveled before furnace was built.*

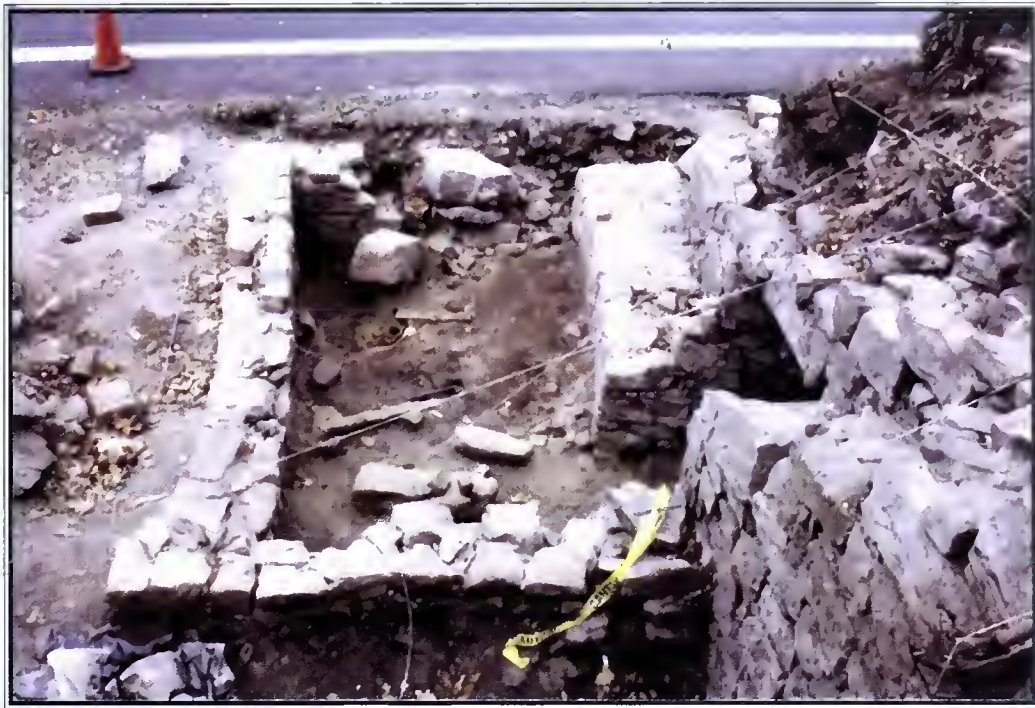
*East room at Rockhill Furnace after excavation. Iron artifacts are scattered across the surface of the intact work floor.*
